**COMMISSION FOR  
HISTORICAL & ARCHITECTURAL  
PRESERVATION**

**STAFF REPORT**

**REQUEST:** Construct five-story addition along West Baltimore Street

**ADDRESS:** 1 North Carey (Union Square Historic District)

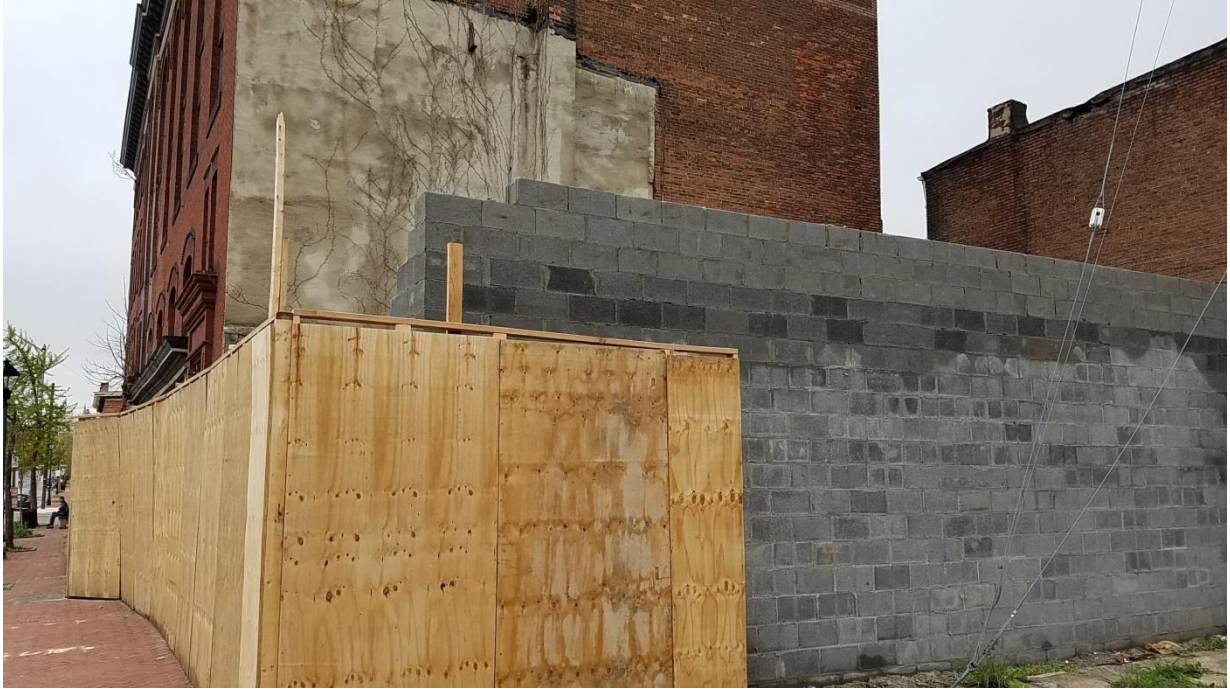
*Image 3:* Image of construction without a permit to begin construction of the new addition.

- June 4, 1995 – 1218 and 1220 W. Baltimore Street, the two rowhouses at the location of the proposed new addition, were condemned following a fire that caused the collapse of the roof and interior of the properties.
- September 13, 1995 – 1218 and 1220 W. Baltimore Street were demolished by city crews citing conditions dangerous to the public welfare.
- February 25, 2011 – Partial Condemnation Notice Issued by Housing.
- July 14, 2016 – Condemnation rescinded
- October 18, 2016 – CHAP staff walked site with architect and owner's representative.
- November 28, 2017 – Stop work order for construction work without permit.
- November 30, 2017 – Work without permit: Building fence around building without permits.
- February 15, 2018 – Work without permit: Construction of rear addition without approval.

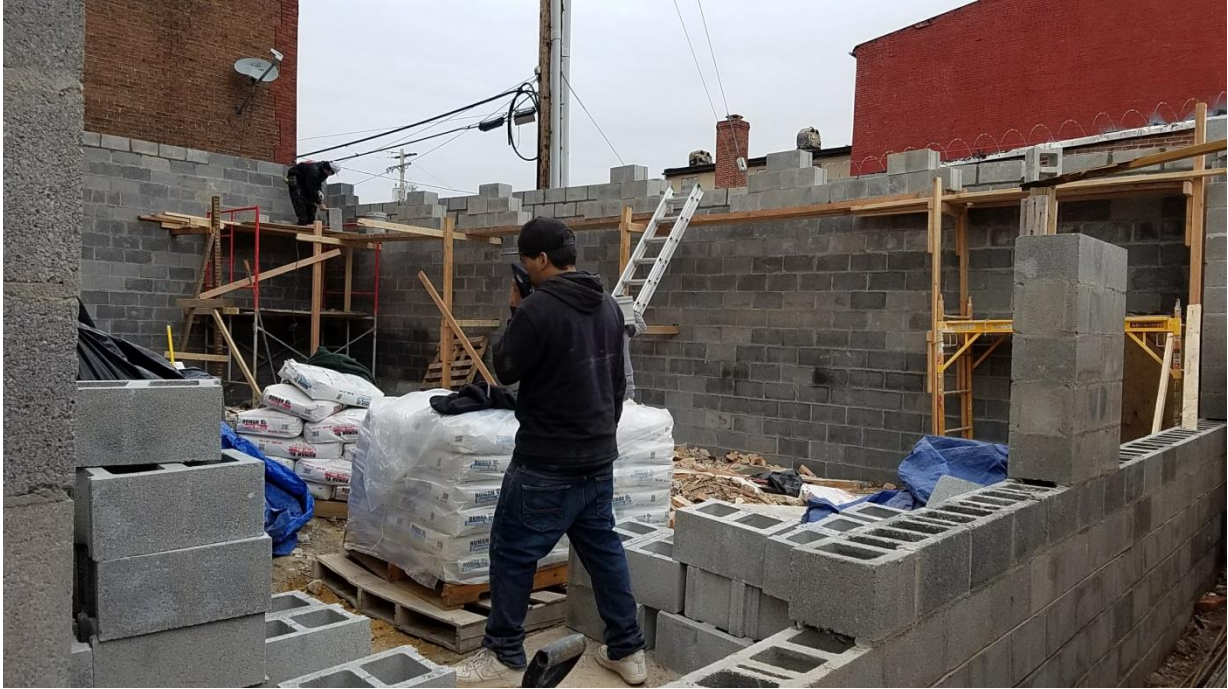
*Image 5: Image of construction without a permit to begin construction of the new addition.*
